**Bath Area Pilot
MAINTENANCE INSPECTION REPORT**

88 Any Street, Bath

April 2003

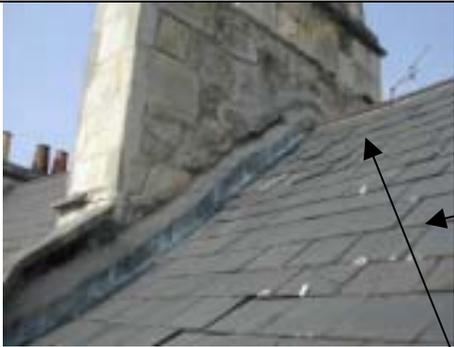
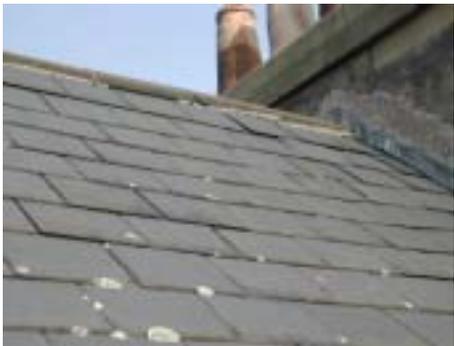
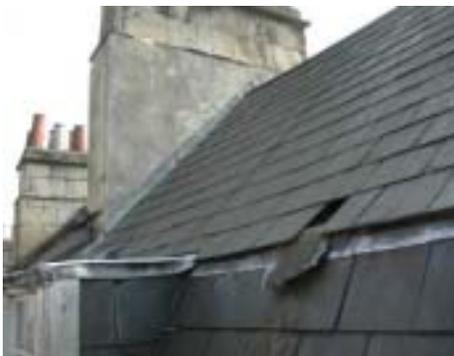
<p>1.1</p> <p>Roof coverings</p> <p>Main Building</p>	<p>Natural slate roof covering to front and rear roof slopes. Mansard roof construction with dormer window extensions set into roof structure to lower pitches to both elevations. Detail between change in roof pitch is protected by an external lead flashing and with internal roofing felt (sarking).</p> <p>Roof coverings in reasonable condition, evidence of metal tingles holding a number of slates into position. Surface of slates to front elevation slightly more weathered due to increased exposure to pollution and climate variations.</p> <p>No evidence of loose/slipped slates, roof vents have been installed to rear roof slope. No evidence of water ingress internally within roof void or top floor flat.</p> <p>Stone ridges are present to the apex of both pitches, appear to be well bedded/secure, minor pointing defects seen, especially to more exposed front elevation.</p> <p>Lead flashings present at junction with slate roof coverings and party walls. Lead in reasonable condition though past cement pointing repairs are evident adjacent to base of chimney stacks. Quality of past pointing repairs is poor in areas with cement cracking and ‘blowing’ off face underlying stone.</p> <p>Outlet to secret gutter is evident to rear roof slope. Outlet drains directly onto roof slope; there is no hopper head/downpipe present. Lead detailing to outlet is weathered and worn.</p>	<p>Inspect slate roof coverings every 6-12 months. Ensure that slates remain well secured and use tingles to refix loose/slipped slates.</p> <p>Ensure that roofing felt and lead flashings at change in roof line adjacent to dormer windows remains watertight and secure. Any worn/defective areas should be replaced. Ensure that ventilation grills within slate vents remain clear and unobstructed.</p> <p>Ensure that stone ridges remain well bedded and secured. Repoint loose/defective mortar where missing and replace worn/decayed stones where necessary.</p> <p>Inspect lead flashings annually. Ensure that lead is well detailed into party wall junctions and below slates. Hack off loose/defective past cement mortar and replace in hydraulic lime mortar. Ideally existing render to stacks should be replaced at the same time to ensure continuity of finish.</p> <p>Provide appropriate hopper head and downpipe for outlet for secret gutter. Ensure that it is well detailed against slate covering and is secured with fixings. Lead overflow must drain adequately into hopper head.</p>	<p>D</p> <p>D</p> <p>C</p> <p>C</p> <p>C</p>

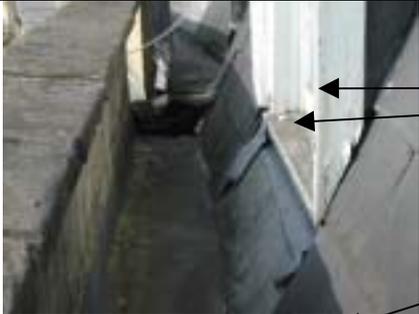
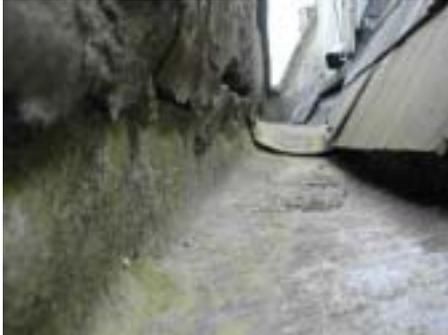
<p>2.1</p> <p>Parapet walls & gutters</p>	<p>Lead gutters are in reasonable condition. Laid to falls with debris present to both. Front parapet shares gully outlet with adjacent building. (No 7). No wire mesh/balloon grating to either gully exit. Rear gutter drains onto a lead flat roof area above the main stairs to property. No splits or tears were visible in the lead lining and no water penetration was noted internally within the roof void.</p> <p>Ashlar block wall construction to both front and rear elevations. Front parapet wall has been rebuilt in the past with new stone and is in good condition. Stone copings are present to both parapets. A number of new copings have been replaced to party wall junction</p> <p>Rear parapet wall was weathered and worn. Internal face of wall had been repaired/repointed in the past. Most areas were cracked and ‘blowing’ off face of wall. Many areas of loose/defective cement render.</p> <p>External surface to stone copings, weathered and worn to both parapets. A number of loose stones to both front and rear, especially at jn. with flat roof over stairwell.</p> <p>Lead reasonably well detailed into internal face of parapet walls and under eaves level slates. More pointing defects to rear parapet wall than the front wall.</p> <p>Upper surface of cornice to both front & rear parapet walls not protected by lead sheeting/flushing detail.</p>	<p>Leave s and mud removed from gutters. Dead pigeon removed from gully.</p>	<p>Clear and clean parapet gutters every 4-6 months. Ensure that all debris is cleared and that both gully outlets are flushed through and remain clear. Ensure that lead remains well detailed under eaves level slates. Provide balloon grating for both outlets.</p> <p>Check stability of ashlar block to rear wall. Replace worn/decayed stones where necessary. Remove existing internal cement render/pointing to internal face and apply 3 layer lime mortar mix. Ensure that lead flashings and upstands are well detailed into wall before application of render.</p> <p>Annual inspection of lead linings, flashings and upstands to both parapets. Ensure that all pointing defects are repaired, hack out all loose/defective mortar that is identified.</p> <p>Repoint/rebed all loose/unstable copings. Replace worn/defective stones where necessary. Inspect copings to party walls annually, ensure that pointing is well detailed and watertight.</p> <p>It may be necessary to provide lead detail over upper surface to stone cornice to front and rear elevations. Ensure that lead is well detailed into face of external parapet wall.</p>	<p>D</p> <p>B</p> <p>C</p> <p>C</p> <p>C</p> <p>C</p>

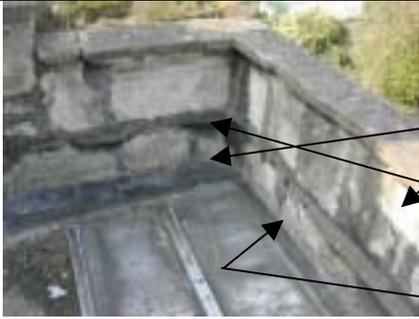
3.1 Lead flat roof.	<p>LEAD FLAT ROOF - Timber deck, lead flat roof to rear elevation sited over main stairwell to house. Laid to falls with some debris noted to external surfaces. Lead 'rolls' that form junctions between each lead sheet, well jointed and detailed, no evidence of water penetration internally.</p> <p>Surrounding ashlar parapet wall weathered/worn. Past cement pointing repairs evident. Slate 'drip' detail has been inserted to lower course of stone to internal face. Stone copings also are worn, some stones are loose with areas of defective/missing pointing.</p>		<p>LEAD FLAT ROOF - Annual inspection of lead coverings. Ensure that lead rolls are well detailed and all joints and seams remain watertight. Check lead flashings are well pointed into parapet wall and repoint loose/defective mortar.</p>	D

3.2 Mono-pitch roof	<p>Surface water from this area and rear gutter drains into lead gullet & hopper head. Lead not well detailed into wall opening, adjacent stone work and copings poorly pointed, potential for water to overshoot hopper head and drain down external surface of adjacent wall.</p> <p>MONOPITCHED ROOF. Small single storey building used for storage. Natural slated roof covering, evidence of past slate repairs. Larger, poorly sized slates have been inserted into covering adjacent to flashing detail.</p> <p>Slate covering is in reasonable condition, lead flashing into main wall of building is well detailed and pointed. Slates drain into eaves level uPVC guttering, decorative condition to fascia board is fair, some flaking paint to timber surface. Pointing to junction between gable end wall and underside of slates is fair, some cracking noted.</p>		<p>Replace loose/chipped slates set into internal face of wall, ensure that gaps between slates are filled with mastic and repoint areas of defective mortar. Check stability of ashlar stones, replace worn/decayed stones, repoint decayed/loosed mortar.</p> <p>Renew lead detail to gully opening. Ensure lead detail drains into hopper head correctly. Repoint loose/defective mortar to wall opening. Rebed loose copings adjacent and check stability of cornice stones, repoint open joints.</p> <p>MONOPITCH ROOF- provide correctly sized slates adjacent to flashing detail. Ensure that slates are held in place by metal tingles. Annually inspect condition of pointing to lead flashing, repoint loose/defective areas.</p> <p>Clear and clean uPVC guttering/downpipe, redecorate timber fascia in next 12-18 months, check timber for signs of decay. Repoint cracks mortar to under side of slates to gable end wall</p>	<p>C</p> <p>C</p> <p>B</p> <p>C</p> <p>C</p> <p>C</p> <p>C</p>

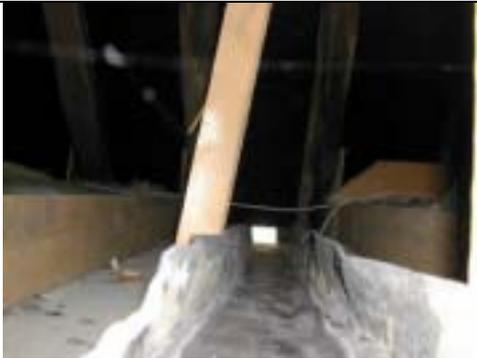
4.1 Secret Gutter.	<p>Lead lined secret gutter to rear roof void, draining directly onto external slate roof covering. Lead lining is in reasonable condition, laid to falls correctly and no evidence of debris or ponded water within gutter. Vertical lead sides are warped and sagging in places.</p> <p>No wire mesh/grill present to outlet within central valley area or exit onto roof slope.</p> <p>Secret gutter present only to rear void, front parapet gutter drains directly into shared gulley opening/hopper head on front elevation.</p>		<p>Clear and clean lead gutter to rear void area every 4-6 months. Ensure that debris is not allowed to collect in gutter.</p> <p>Provide balloon gratings to both gulley exit/entrance to secret gutter.</p> <p>Consider provision of timber box frame support to prevent sagging and deformation of lead to vertical sections.</p>	<p>C</p> <p>B</p> <p>D</p>

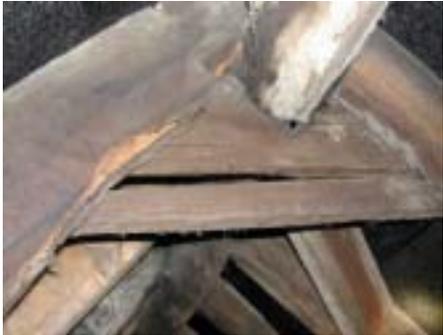
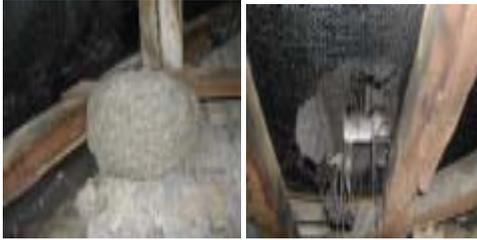
4.2 Roof Void	<p>Traditional timber trussed roof construction. Evidence of past repairs to strengthen existing timber. New timber has been inserted in a number of locations. Timbers placed to support/strengthen apex of roof have split.</p> <p>Roof void has been lined internally with roofing felt (sarking), some areas have been damaged/torn by birds nesting in eaves etc. Presence of a number of small wasps' nests attached to rafters.</p> <p>Some rafters have split along the line of the grain, timbers are not deflecting/bowing but integrity of timber could be weakened.</p> <p>Insulation present to both voids, ventilation provided by secret gutter to rear void area, no permanent means of ventilation seen to front roof void area.</p> <p>No means roof hatch provided to allow access to central roof valley area.</p>		<p>Annually inspect roof timbers for insect attacks and decay. Ensure that timber are not bowing/deflecting.</p> <p>Replace torn/damaged roofing felt internally and remove all wasps' nests in void areas. If point of access can be determined in roof coverings seal holes/gaps.</p> <p>Piece/splice in timber where rafters have split, check timbers for cracking especially adjacent to knots in wood which are susceptible to weakening.</p> <p>Ensure that insulation is placed well away from eaves level areas. This will allow better ventilation within void areas. Provide ventilation slates within front roof slope.</p> <p>Access to central roof valley is vital, provision of a timber framed access hatch should be considered in very near future</p>	<p>D</p> <p>C</p> <p>C</p> <p>C</p> <p>A</p>

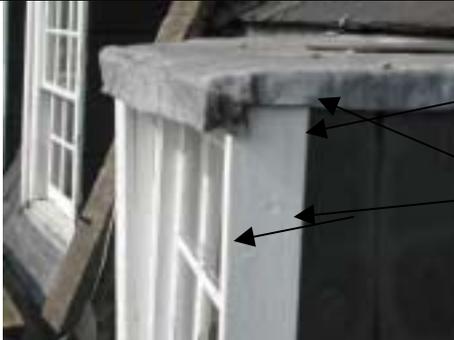
5.1 Dormer Extensions	<p>Lead lined dormer roof extensions to both front and rear elevations. Lead flat roof areas and slate vertical 'cheeks' detailed into main slate roof covering adjacent. Lead covering to roof is generally in fair condition, surfaces weathered and worn. Lead flat roof laid to falls, drains onto window joinery below, no lead integral gutter present at eaves level. Seams and junctions of lead sheeting not very well detailed or welded correctly.</p> <p>External joinery weathered/worn with areas of bare wood and peeling/flaking paint especially to cill areas. No signs of water penetration internally, sash windows stiff and difficult to operate easily.</p> <p>Lead flashing detail at junction of dormer extension and main roof covering in fair condition, a number of gaps were noted between timber frame of sash window and vertical slates.</p>		<p>Carry out annual inspection of dormer extensions. Ensure that vertical slates remain well secured and nailed to timber frame, refix loose/slipped slates.</p> <p>Clean off debris from dormer roofs as required, ideally an integral lead gutter should be formed at eaves level to shed water away from window joinery. It may be necessary to replace all/some of the lead sheeting to the flat roof area to achieve this.</p> <p>Mastic all gaps that are present between vertical slates and timber frame. Ensure all voids/gaps are sealed and watertight/. It is v important that water is shed away from this area.</p> <p>Redecorate all joinery and overhaul all existing sash windows so they operate correctly/smoothly.</p>	D

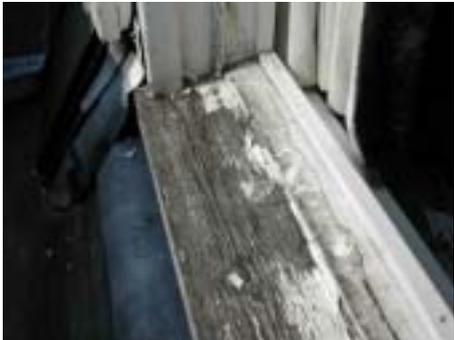
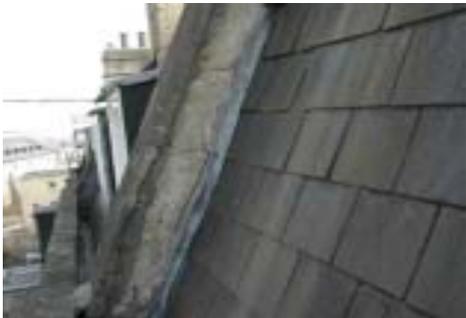
5.2 Flashings	<p>Lead flashings present at junction of roof coverings and party walls. Pointed into wall with cement pointing. Numerous past repairs evident to most areas. Cement render is cracked and 'blowing' off face of party wall.</p> <p>Stone copings adjacent, weathered and worn surface, generally well bedded, past cement repairs evident to lower surface adjacent to party wall. Leading edges of copings missing and defective, some stones have been replaced.</p>		<p>Annual inspection of flashing details is advised. Repoint defective/loose mortar to all party wall areas and base of stacks. Ideally all internal faces of party wall should be rendered in 3 layer limed based render to provide sufficient protection to this exposed area.</p> <p>Ensure all copings to party walls are well bedded and secured. Repoint loose/defective mortar. Replace decayed/worn stones especially where they are damaged/missing.</p>	C C C

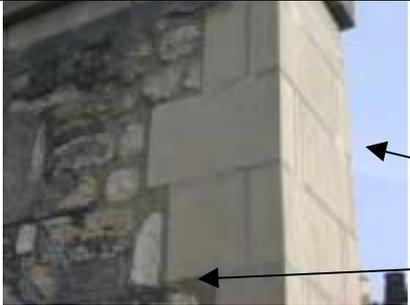
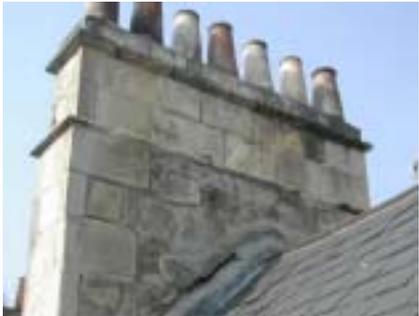
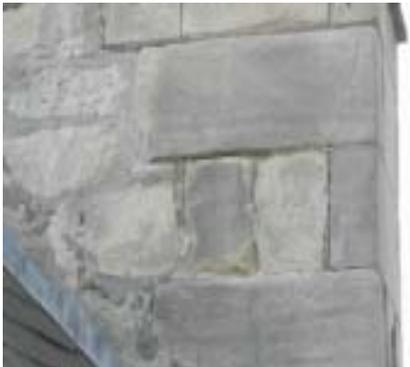
<p>6.1 Chimneys</p>	<p>Mixture of ashlar stone and rubble wall construction to both front and rear stacks sited on the party wall junctions. All stacks are shared with adjacent properties and are in reasonable condition.</p> <p>No evidence of cracking or leaning. Front stack to SE corner has been partially rebuilt using new ashlar stone.</p> <p>Moulded bandcourses and higher level cornice details are weathered and worn especially to more exposed (SE) front elevation.</p> <p>Evidence of numerous past cement pointing repairs to rubble wall sections. Small areas of defective pointing where cement is 'blowing' away from surface of stone.</p> <p>Clay pots appear to be well bedded and secured, condition of flaunching not assessed as access to central roof valley area was not possible.</p> <p>Lower courses of rubble wall to NE & SE stack are rendered, reasonable condition, some hairline fractures present due to high level of cement within render mix. Base of stacks generally well detailed into roof structure and coverings adjacent. Lead flashings pointed into base of stacks. Past repointing repairs evident, some areas cracked and in poor condition.</p>		<p>Annually inspect overall structural condition of stacks. Look for any cracking and deflection/leaning of stacks.</p> <p>Ensure that clay pots remain secure. If access to central valley area is gained it is important to check condition of flaunching and repair any cracks or defects seen. Rebed loose pots and renew pots if cracked/defective.</p> <p>Repair damaged/missing sections of band course and cornice details. Renew worn/decayed sections.</p> <p>Hack off all loose and defective cement mortar pointing to all areas of rubble and ashlar stone. Renew in hydraulic lime mortar which will 'weather' far better in exposed conditions. Assess condition of individual stones, replace if worn/decayed.</p> <p>Ideally cement render to stack adjacent to No 9 should be removed and renewed in a 3 layer limed based render. This should be well detailed into the existing lead flashings and run into the lower party wall areas. Ensure that all lead flashings to the base of the stacks are well detailed and all pointing is sound. Hack out loose/defective pointing and renew. Renew worn lead sections if necessary and ensure that lead is well detailed under adjacent roof coverings.</p>	<p>D</p> <p>C</p> <p>C</p> <p>D</p> <p>C</p> <p>D</p> <p>C</p>

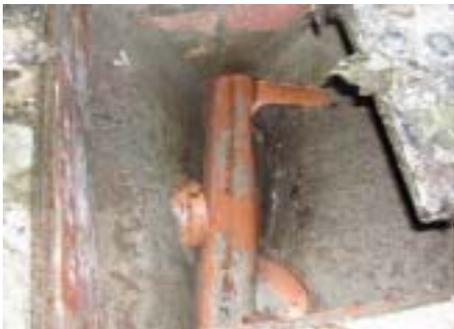
<p>A number of other open gullies were present to the rear courtyard, front basement and vaulted areas. These appeared to be running clear with no obvious odours or blockages to these areas. Cast iron gratings over original gullies showed surface corrosion.</p>		<p>Check fixings and ensure joints and seams remain watertight. Replace sections that are too corroded. Paint all sections of iron downpipe.</p>	C
				<p>Inspect below ground drainage annually. Lift all accessible drainage hatches and flush through. Lift open gulley covers and clear any debris from within openings. Ensure that gulley adjacent to rear downpipe remains clear and clean.</p> <p>It is likely that this is a combined (foul and surface) system. Blockages within the small diameter pipework can be harder to clear if left unchecked.</p>	C

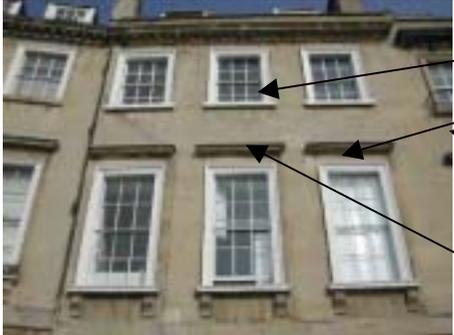
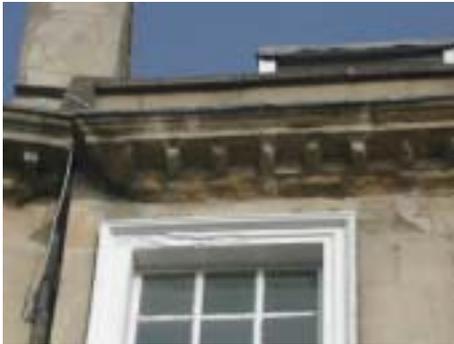
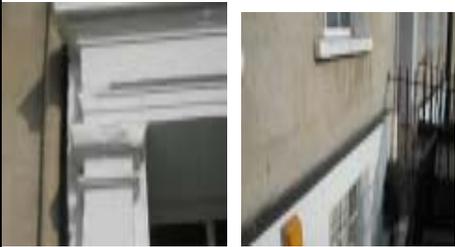
<p>7.1</p> <p>Front Elevation</p>	<p>Ashlar block to main elevation, well cut, dressed and pointed. Rubble wall construction to basement levels and vaulted areas below pavement level.</p> <p>Little sign of movement, a number of open joints to window openings to 1st & 2nd floor level following the line of the mortar.</p> <p>Mouldings above openings and decorative cornice detail adjacent to parapet wall are severely weathered and worn, especially to high-level stonework. Decorative dentils are missing and badly corroded. Upper horizontal surfaces have been protected by lead detail/covering but effects of pollution and weathering have decayed extensive sections of stone.</p> <p>There is only a limited amount of surface staining to ashlar stone below cills and cornices, stone may have been cleaned in the past.</p> <p>Surface decay to stone pilasters to main entrance porch, flat roof area is detailed in lead.</p> <p>Basement wall area is made from ashlar stone recently painted. Ground level is made up from a mixture of original flagstones (cracked & uneven) and newer concrete slabs spanning over void of sub basement below. Slate detail set into ashlar wall to prevent water from draining directly onto external face of basement wall below. Original stone steps have been replaced with metal tread open stairs that lead to basement level flat entrance. Minor surface corrosion noted, especially to fixings into adjacent walls.</p>	<p>Annual inspection of ashlar wall is advised, check for any further cracking or movement adjacent to existing open joints to window openings.</p> <p>Repoint all open joints and cracks in lime putty mortar, ensure all defective mortar is racked out before repointing.</p> <p>Decayed and defective stone details to cornice level should be replaced. Check stability/integrity of existing stones. Due to high level of surface corrosion, wholesale replacement may be only option. Ensure that lead detailing above remains intact and well pointed into parapet wall adjacent. Listed building consent may be required.</p> <p>Assess condition of stones to mouldings above window openings. Replace decayed/worn stones where necessary. Ensure that lead detailing above remains intact and well pointed into parapet wall adjacent. Listed building consent may be required.</p> <p>Ensure that slates at basement level remain well detailed into main wall. Replace cracked/damaged slates; fill gaps between with mastic sealant.</p> <p>Relay loose/damaged flagstones; ensure that they are laid to drain away from building.</p> <p>Surface corrosion should be removed and painted. Ensure that fixings into walls are secure. Remove defective/loose stone and provide sleeve/expansion joints to allow for movement of fixings within wall. Repoint all fixings.</p>	<p>D</p> <p>C</p> <p>C</p> <p>C</p> <p>C</p> <p>C</p>

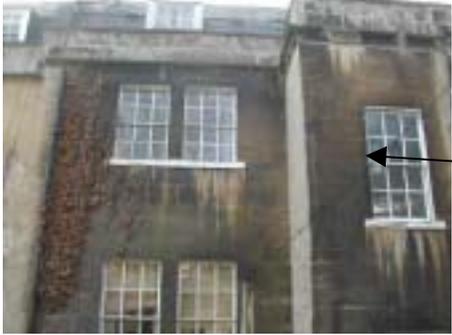
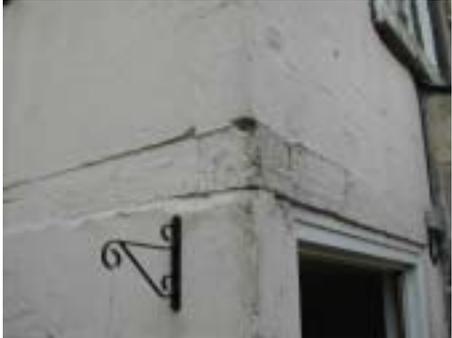
<p>8.1 Rear Elevation</p>	<p>Ashlar block construction to main elevations, rubble wall construction to basement areas. Walls are heavily stained to all areas due to sheltered conditions. Upper levels of wall have remains of dead creeper/vine.</p> <p>Evidence of movement to lintels to 1st floor level. Cracks have opened up along mortar lines to stairwell area also. Parapet wall is weathered and worn, no evidence of movement, past pointing repairs evident.</p> <p>Timber lintels noted above rear door extension minor surface decay noted, timber painted, end grain exposed to both walls. Exposed timber wall plate noted at high level below cornice detail to stairwell area. Visual inspection revealed that timber was not painted, though wood is likely to be hardwood, surface decay maybe present. No movement/deflection noted to either area.</p> <p>Stone cills in poor condition, areas of defective stone, missing with damaged sections. Staining to walls below where stone has been 'washed' by surface water. Similar condition of stone was noted to cornice. Upper surface of stone was not protected by lead sheeting.</p> <p>Grd level courtyard area remains in reasonable condition. Areas of moss/vegetation growing within mortar to flagstones. Flagstones remain well bedded and pointed, drain into open gulley, concrete channel. Wrought iron grill over basement area in fair condition, surface corrosion to fixings into walls, especially to lower metal plate fixed to wall.</p>	<p>Annual inspection of ashlar wall is advised, check for any further cracking or movement adjacent to existing open joints to window openings and stairwell area.</p> <p>Repoint all open joints and cracks in lime putty mortar; ensure all defective mortar is racked out before repointing.</p> <p>It is preferable that rear elevation is cleaned. Specialist advice should be sought and listed building consent may be required.</p> <p>Assess condition of stones to cornice and parapet area. Repoint open joints and replace decayed/worn stones. Provide lead detail to upper stone surface of cornice. Ensure that lead is well detailed into parapet wall.</p> <p>Replace sections of damaged cills ensure that an adequate drip detail to lower surface is provided and stone is well pointed into window opening. Remove vegetation from flagstones. Ensure that mortar is sound, repoint defective areas. Ensure that drainage gulley/channels remain clear.</p> <p>Improve detail at grd level to door opening, provide weather bar/strip to restrict surface water entering from courtyard area.</p> <p>Remove surface corrosion, paint all areas. Ensure that fixings into walls are secure.</p> <p>Remove loose stone and provide expansion joints to allow for movement of fixings</p>	<p>D</p> <p>C</p> <p>D</p> <p>C</p> <p>C</p> <p>C</p> <p>B</p> <p>C</p>

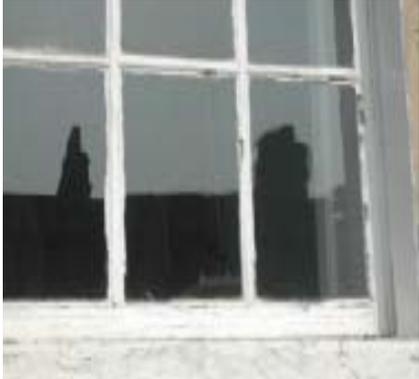
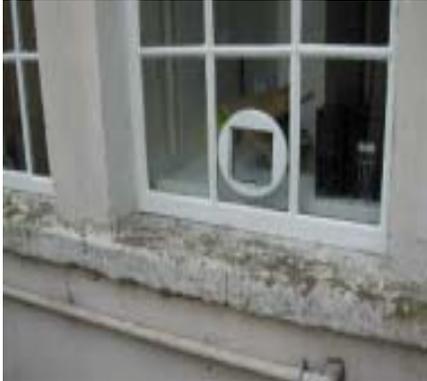
<p>9.1 Joinery</p>	<p>Timber sash windows to both front and rear elevations. General condition of external joinery is poor. High levels of pollution and climatic variations make front elevation more vulnerable. Numerous areas of flaking and peeling paint with missing putties to individual panes. Surface timber decay noted to joints to glazing bars and at junctions with frames.</p> <p>Stone reveals and cills are painted, defective pointing and gaps noted at junction with timber frame and ashlar stone.</p> <p>Windows to rear basement courtyard area have recently been decorated and are in better condition.</p> <p>Dormer windows at roof level are in generally poor condition, peeling and flaking paint noted to cills and sashes. Water drains directly from lead flat roof onto joinery below. Gaps noted between frame and vertical tiles.</p> <p>Main panelled front door in reasonable condition. Door furniture and locks operating correctly. Minor split/cracks noted to panels within door. Decorative condition is fair.</p> <p>Rear garden door in reasonable condition, minor open joints to lower panels. Limited weathering detail to prevent surface water from entering at floor level.</p>		<p>Annually inspect condition of windows and frames. Pay particular attention to joints where water can penetrate and open up joints and decay timber.</p> <p>Ease and adjust all windows, inspect condition of cords, weights and pulleys. Ensure all sashes are operational. Replace worn/defective cords and pulleys.</p> <p>Carry out minor joinery repairs to glazing bars, sashes and frames. Replace missing putties where necessary.</p> <p>Repoint all gaps to stone window reveals, ensure watertight detail. Ideally paint should be removed from all window reveals and cill surfaces.</p> <p>Redecorate all joinery to front and rear elevations in next 12-18months. Scaffold access equipment will be required, consider carrying out other essential repair to stonework etc at same time</p> <p>Fill in minor cracks to panels within doors; ensure all joints are well protected and decorated. Ease and adjust door furniture.</p> <p>Provide weather bar/stop at floor level to rear door frame to restrict external surface water from entering into building from courtyard area.</p>	<p>D</p> <p>C</p> <p>C</p> <p>C</p> <p>D</p> <p>D</p> <p>C</p>

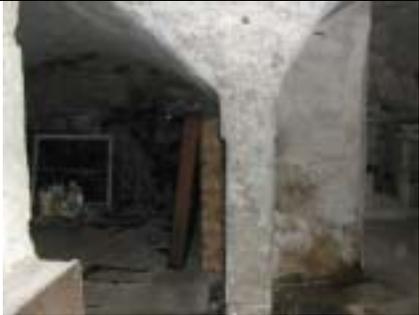
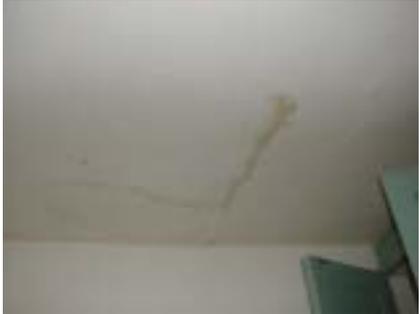
<p>10.1</p> <p>Base-ment & vaulted areas</p>	<p>Rubble stone wall construction to vaulted cellar areas, sub-basement and converted basement flat.</p> <p>SUB BASEMENT – Sited below main footprint of house. Original flagstones to floor, evidence of staining to some area due to ponded water. Walls remain in good structural condition, no evidence of cracking, surface of walls are damp which is expected to these areas. Surface flaking of masonry paint; some pointing defects to areas of rubble walls. Stone steps lead up to vaulted cellar areas below pavement level.</p> <p>VAULTED CELLARS – Rubble wall construction. Iron ties/reinforcement ties have been inserted to sections of walls to both cellars. Badly corroded to all areas, integrity of ties not known or tested. Extensive cracking to spine and boundary walls. Extensive mould growth and penetrating damp to boundary and external walls. Flagstone floor uneven, areas are stained due to damp conditions. Stone steps lead up open courtyard area and converted basement flat.</p> <p>BASEMENT FLAT – Converted basement area, originally used as kitchen and servants quarters. Stone hearths and fireplaces overhauled and refurbished. External walls not drylined, no evidence of penetrating damp. Concrete floors remain in sound condition, floor coverings are dry. Minor staining to ceiling plaster in kitchen. Leak to waste pipe above has been repaired, unlikely to be continuing as plaster finish would show evidence of increased staining/damp penetration.</p>	<p>SUB BASEMENT - Annual inspection of this area. Check wall and ceiling areas for movement/cracking. Ensure that flagstone remain even and be aware of any deformation or cracking to grd level. Repoint defective mortar to rubble walls and ensure that drainage gulleys are kept clear. Ensure that areas remain ventilated.</p> <p>VAULTED CELLAR AREAS – Specialist advice should be sought regarding present level and extent of cracking to boundary and spine walls. It is understood that this cellar was not covered in recent ‘basement’ survey by B&NES. Continual vibration and traffic movement adjacent could have damaging effects on integrity of rubble wall, especially as damp condition prevail in this area. Effectiveness of cast iron ties is not known/clear.</p> <p>All defective pointing should be hacked out and repointed; decayed stones must be replaced. Ensure that open gullies remain clear and clean. Ideally flagstones should be relaid/rebedded, ensure that they are laid to drain towards gullies/channels</p> <p>BASEMENT FLAT – Ensure that flat remains well ventilated and aired. Ensure that existing chimneys are open to provide sufficient ventilation. Replace defective ceiling plaster to kitchen, check to ensure that pipework above is sealed and correctly jointed. Redecorate all new plasterwork.</p>	<p>D</p> <p>B</p> <p>B</p> <p>D</p> <p>C</p>

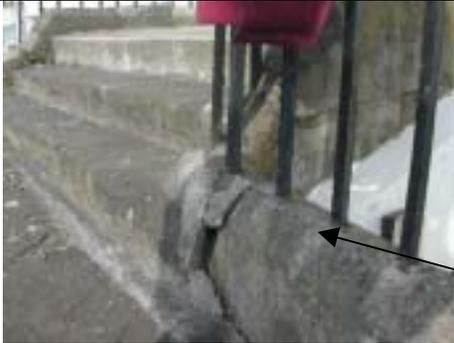
<p>11.1 Courtyard Areas</p>	<p>FRONT COURTYARD AREA - Rubble wall construction to retaining wall to vaulted cellar area. Mixture of new concrete slabs and original flagstones to basement floor area. Flagstones cracked/uneven, concrete slabs span over basement void below. New metal open tread staircase leads down to courtyard area.</p>		<p>FRONT COURTYARD AREA. – Relay loose/cracked flagstones to basement area. Ensure they drain away from building. Renew corroded railings and place in lead wells within stone plinth proud of stone surface. Remove surface corrosion, redecorate railings. Renew sections of damaged/cracked stone plinth, it may be necessary to renew complete section. Ensure that retaining wall to vaulted cellar remains well pointed and inspect walls annually for movement and cracking</p>	C

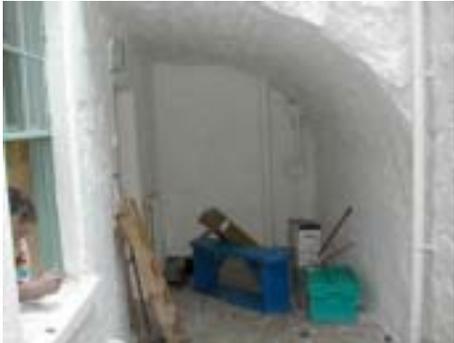
<p>Wrought iron railing present at pavement level, set into stone plinth. Base of railings corroded, lead wells set into stone corroded also. Past cement repairs evident to plinth area. Sections of stone cracked, missing and damaged. Stone steps leading to main entrance in good condition, no evidence of cracking or deflection.</p>		<p>REAR COUNTRYARD AREA – Ensure that this area is swept clear and clean every 2 –3 months, clear all debris for gulleys and check all gully openings for debris/blockages.</p>		C

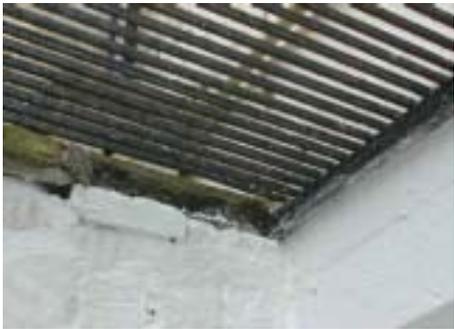
<p>REAR COURTYARD AREA – Rubble wall construction to retaining and boundary walls. No evidence of cracking/movement. Walls recently decorated. Retaining wall remains in reasonable condition, no deflection or bulging of wall, areas of damp to lower sections of wall due to penetrating grd water.</p> <p>Part of vaulted ceiling area remains intact, open section has be secured over with wrought iron grill. Surface corrosion to some sections especially fixings into walls and metal wall plate. Flaking/peeling paint to surfaces. New gulleys installed at basement grd level, floor surface is mix of original flagstones and screed concrete. Concrete in areas is cracked and uneven. Vegetation/moss growing within retaining wall, fed by ground water from adjacent terraced garden.</p>		<p>Remove surface corrosion to grill/bars and redecorate metal surfaces. Ensure fixings secure.</p> <p>Ideally new fixings should be installed with expansion sleeves to allow for movement of metal. Repoint fixings within wall.</p> <p>Annually inspect condition of retaining and boundary walls. Check for movement/cracking and sections of bulging walls. Ensure that all drainage channels within walls are kept clear.</p> <p>Inspect condition of flagstones annually; ensure they remain well bedded and pointed. Repaired areas of cracked/defective concrete screed.</p>		C
