Research Module 4:
Technology- A review
of products and
services within the field
of preventative
inspection and
maintenance of
buildings.

Research Module 4: Technology - A review of products and services
within the field of preventative inspection and maintenance of
buildings.

November 2003

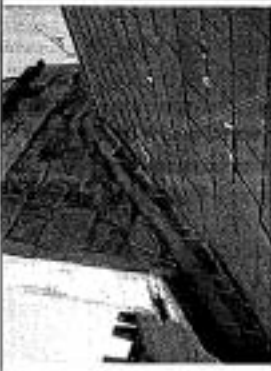
1.1 Roof covering Main Building	Natural slate roof covering to front and rear roof slopes. Mansard roof construction with dormer window extensions set into roof structure to lower pitches to both elevations. Detail between change in roof pitch is protected by an external lead flashing and with internal roofing felt (sarking). Roof coverings in reasonable condition, evidence of metal tingles holding a number of slates into position. Surface of slates to front elevation slightly more weathered due to increased exposure to pollution and climate variations. No evidence of loose/slipped slates, roof vents have been installed to rear roof slope. No evidence of water ingress internally within roof void or top floor flat. Stone ridges are present to the apex of both pitches, appear to be well bedded/secure, minor pointing defects seen, especially to more exposed front elevation. Lead flashings present at junction with slate roof coverings and party walls. Lead in reasonable condition though past cement pointing repairs are evident adjacent to base of chimney stacks. Quality of past pointing repairs is poor in areas with cement cracking and 'blowing' off face underlying stone. Outlet to secret gutter is evident to rear roof slope. Outlet drains directly onto roof slope; there is no hopper head/downpipe present. Lead detailing to outlet is weathered and worn.	Inspect slate roof coverings every 6-12 months. Ensure that slates remain well secured and use tingles to refix loose/slipped slates. Ensure that roofing felt and lead flashings at change in roof line adjacent to dormer windows remains watertight and secure. Any worn/defective areas should be replaced. Ensure that ventilation grills within slate vents remain clear and unobstructed. Ensure that stone ridges remain well bedded and secured. Repoint loose/defective mortar where missing and replace worn/decayed stones where necessary. Inspect lead flashings annually. Ensure that lead is well detailed into party wall junctions and below slates. Hack off loose/defective past cement mortar and replace in hydraulic lime mortar. Ideally existing render to stacks should be replaced at the same time to ensure continuity of finish. Provide appropriate hopper head and downpipe for outlet for secret gutter. Ensure that it is well detailed against slate covering and is secured with fixings. Lead overflow must drain adequately into hopper head.	D D C C C C

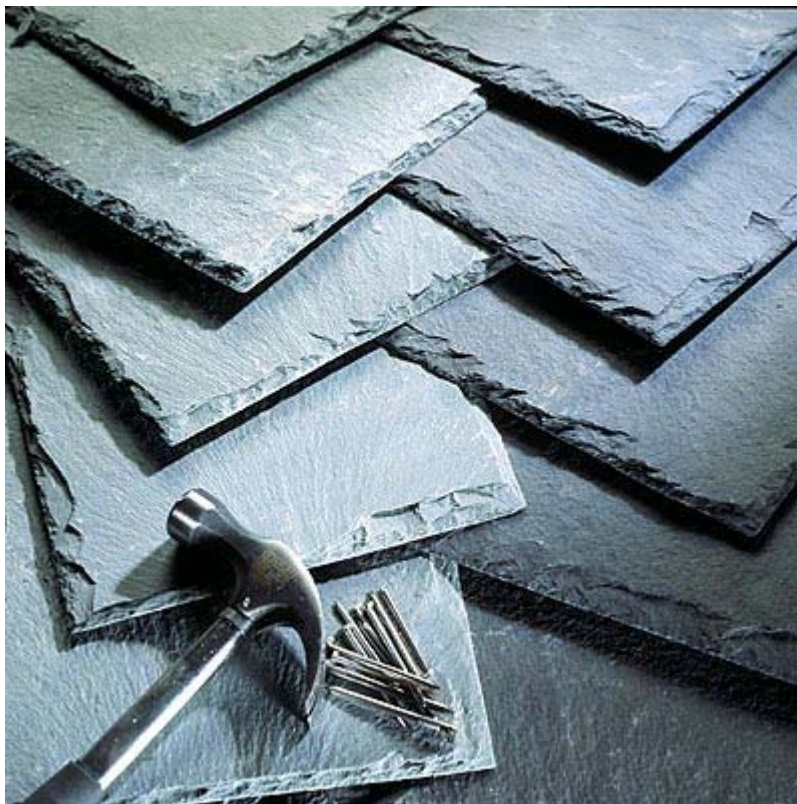
Figure A6.1. Blue-grey slate [Burlington Slate image]

Authentic slate tiles are produced by a small number of companies, two of which are referenced below. Imported materials may also be used provided there is a good match in terms of weathering, colour and texture. Slate colours vary considerably, and those from, for example, Spain or Africa, may not prove to be an adequate match.

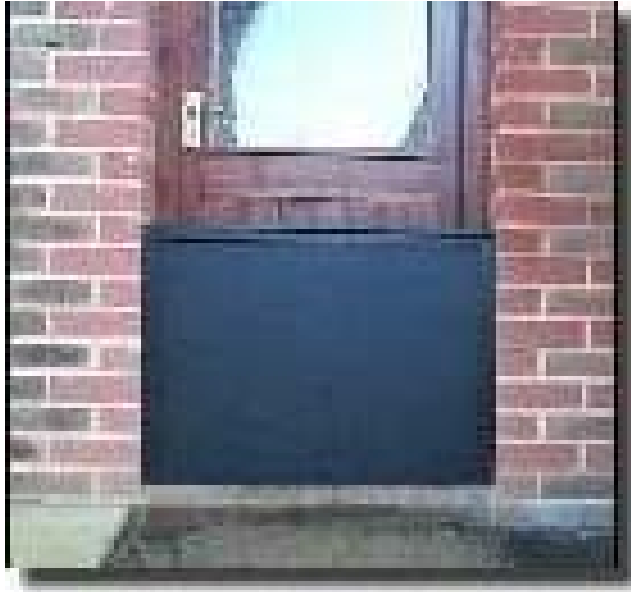
Figure 2. Flood barrier across external door (<http://www.antiflood.com/>)

- Dry-proofing: measures to keep water out of buildings eg barriers to doors and low-level windows, non-return valves on sewers to prevent backflow, covers to airbricks and low-level vents.
